REVISED FLOOD MAPS CAUSE WARWICK TO RECONSIDER THE SAFETY OF ITS TREATMENT PLANT

Dennis Setzko^{1*}, Erik Meserve², Janine Burke³, Joel Burke³, and Patrick Doyle³

¹ AECOM, 500 Enterprise Drive, Suite 1A, Rocky Hill, CT 06067

³ Warwick Sewer Authority, 125 Arthur W. Devine Boulevard, Warwick, RI 02886

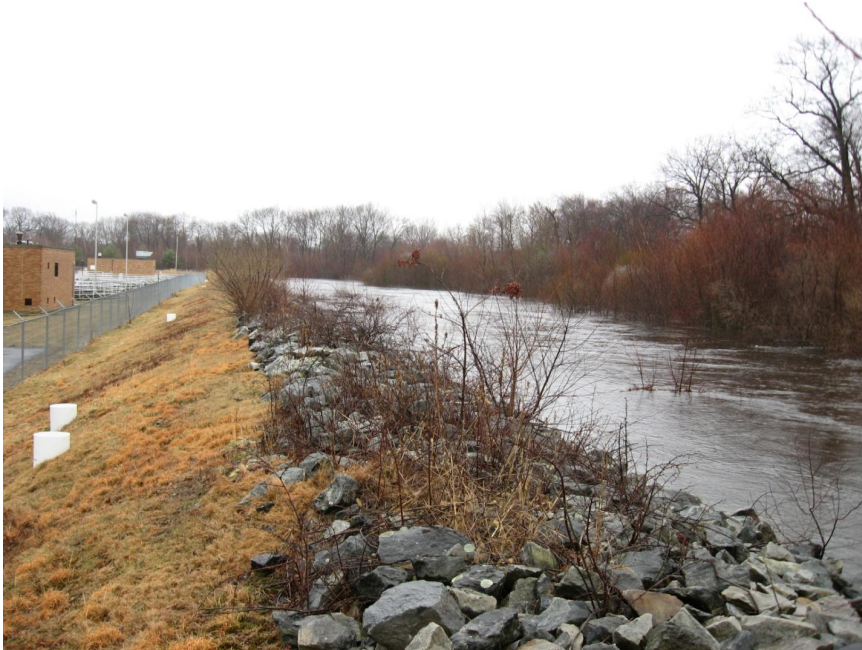
Figure 2: Western Side of Levee at Warwick Wastewater Treatment Facility, March 15, 2010. Photo by Patrick Doyle.

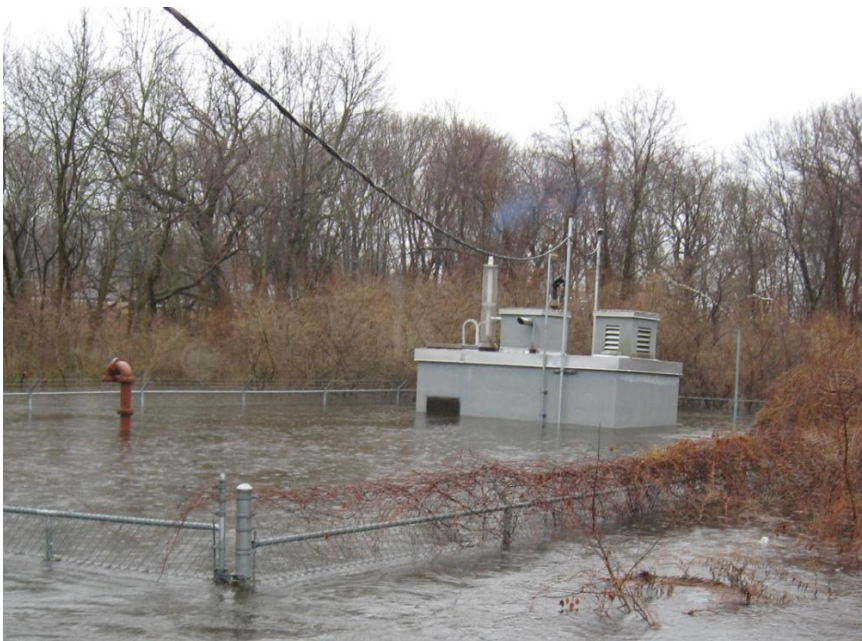
Figure 3: Knight Street Pumping Station, located in a Pawtuxet River floodway, during March 15, 2010 flood. Photo by Patrick Doyle.

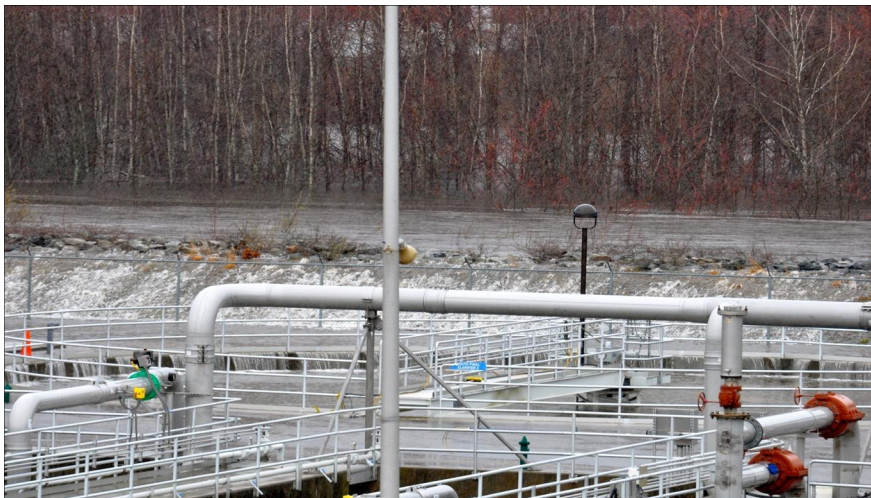
When the storm ended on March 31, 2010 the City had received another 22.35 cm (8.8 inches) of rain. The river crested 0.91 meters (3 feet) above the top of the dike, flooding the plant with over 3 m (10 feet) of water in a matter of hours. Flood waters filled the WWTF campus with an estimated 284 ML (75 million gallons) of stormwater and wastewater, putting an end to all treatment. The flood also completely inundated six (6) pumping station located along the banks of the Pawtuxet River.

This flood was initially classified as between a 100-year and a 500-year event. The month of March set two new records for river level and was the wettest month on record. [Figure 4](#) displays a photo of the site shortly after the levee was breached. [Figure 5](#) displays a photo of the site after the flood waters began to recede.

Figure 4: Pawtuxet River crests the western side of the levee at approximately 1:15 PM on Tuesday, March 30, 2010, and begins flooding the treatment facility. Photo by Peter Ginaitt.

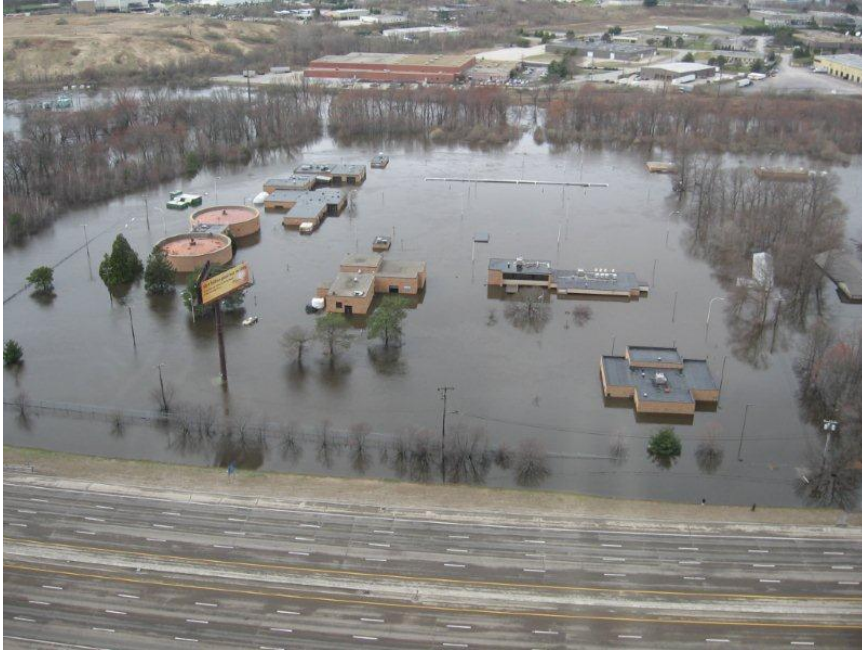
Figure 5: Flooding at the WWTF on April 1, 2010. Photo by Janine Burke.

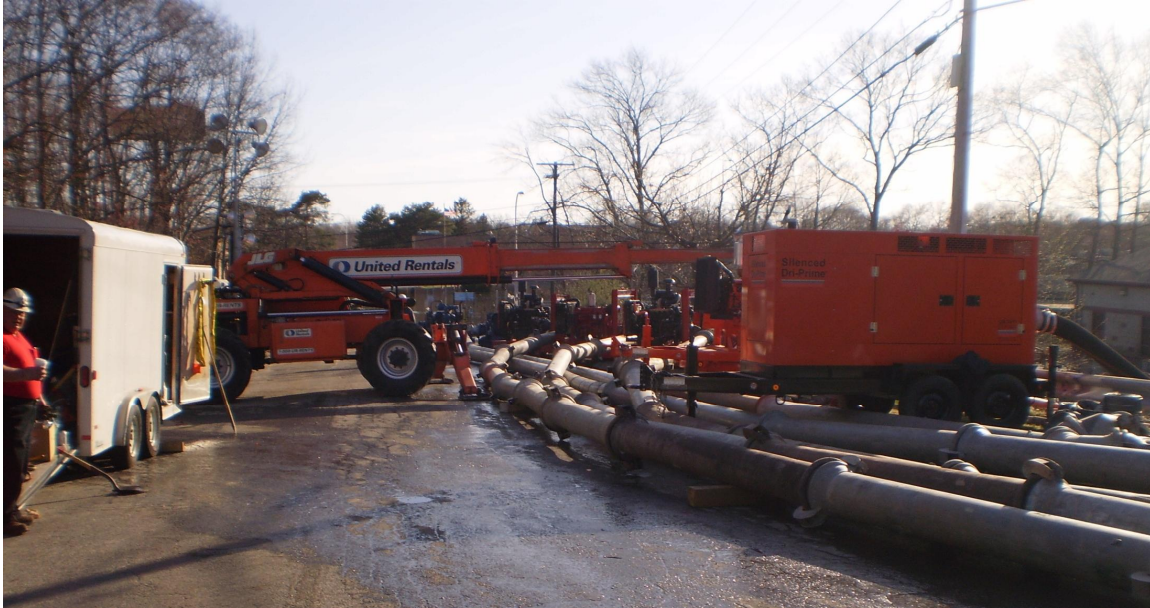
On Friday, April 2nd, large 0.3 m (12-inch) pumps obtained by contractors began arriving from as far away as Indiana. Once these large pumps were set up, the dewatering operations picked up speed. Damage assessments were initiated as soon as equipment became accessible. Problem areas in the collection system had been successfully by-passed while repairs could be completed. Figure 6 shows some of these portable pumps in the early dewatering operation.

Figure 6: Portable Pumps Dewatering the WWTF Site. Photo by Janine Burke.

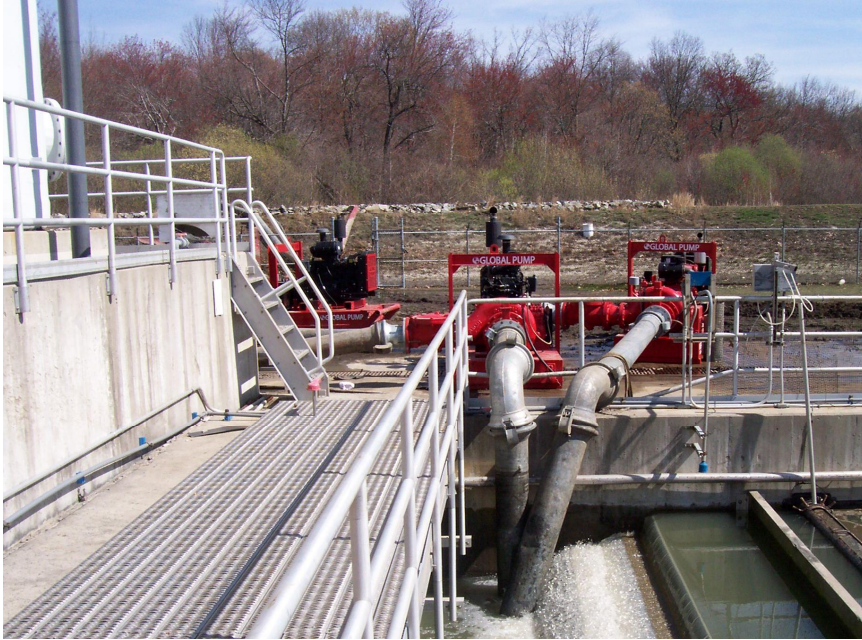
Figure 7: Portable Pumps Pumping Effluent. *Photo by Erik Meserve.*

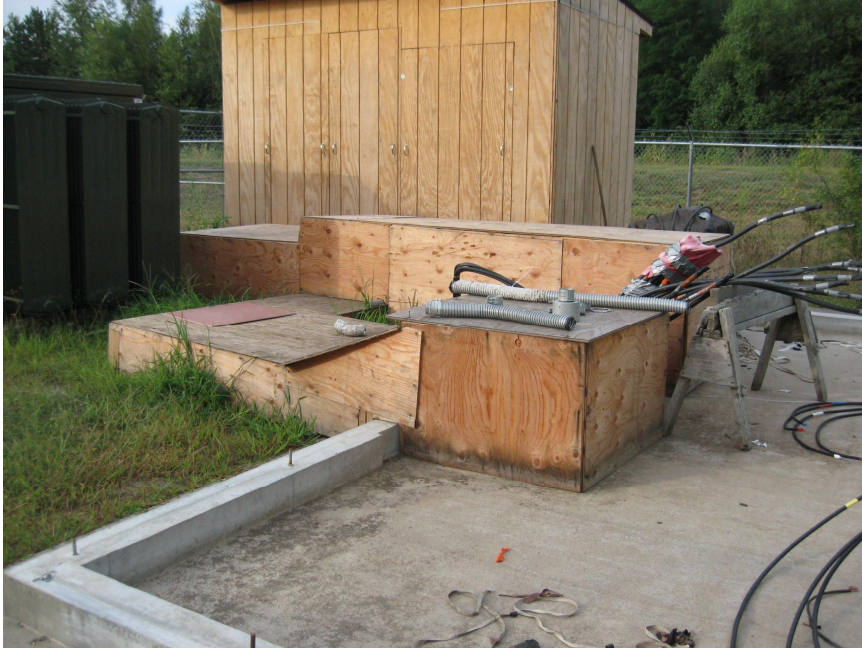
Figure 10: Temporary Switchgear Housing. *Photo by Ron Demers.*

Power distribution on the site during this time was initially done via portable generators at each building. Temporary distribution panels were constructed for each piece of equipment and systems were fed via these panels. The main switchgear, emergency generator and MCCs were removed and replacement equipment ordered. To avoid having to run on portable generators for months while this equipment was manufactured, a temporary switchgear was installed and the portable generators were kept on-site as emergency backup. All equipment at this point manually operated and run at a constant speed with the exception of the aeration blowers which were powered through temporary variable frequency drives.

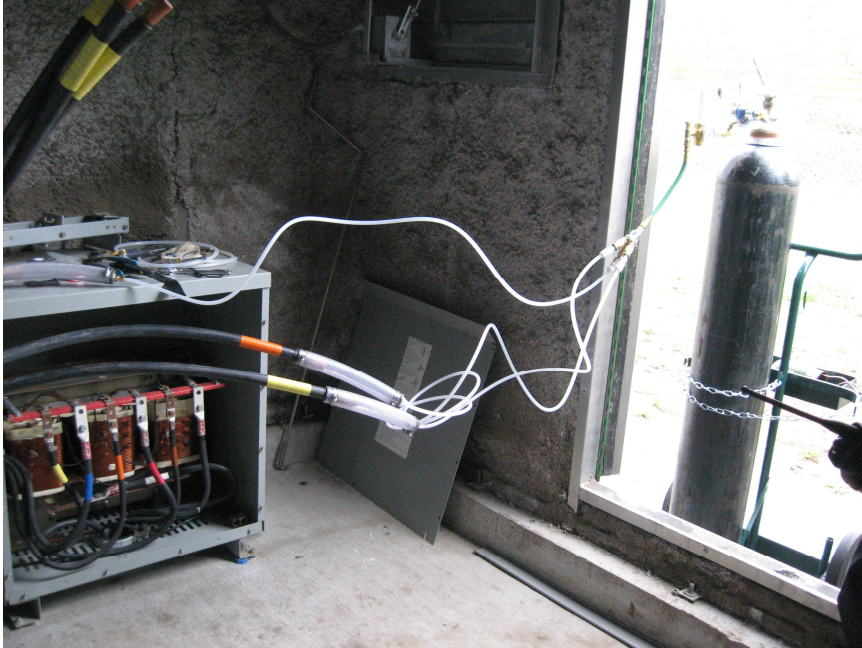
Figure 11: Nitrogen Gas Drying Test. *Photo by Ron Demers.*

Removing and replacing all the conductors on-site would have been extremely time consuming and expensive. Instead, an innovative gaseous nitrogen drying technique was used on conductors 4/0 AWG and larger to speed up restoration and reduce costs. Using this system on smaller conductors was not cost effective. Nitrogen gas at approximately 1.02 atm (15 psi) was forced into each conductor to force the water out of the insulation. This method of drying out the conductors was tried on a small scale at first and then expanded to larger gas manifolds. Refer to [Figure 11](#) and [Figure 12](#) below. Each conductor was dried for a total of approximately four days. At first, water was seen bubbling out of the other end at a constant rate. The rate of water exiting the conductor constantly decreased until it had typically stopped after three days. The protocol used kept nitrogen gas flowing through the conductor for one additional day after the water had stopped. Prior to any drying, all conductors were megger tested to ground and to one another. If the conductor failed the initial test, they were removed and replaced as a failed megger test was an indication of another issue besides water in the insulation. A very small percentage of conductors needed to be immediately replaced. After drying was completed, the conductors were again megger tested to ground and to one another to prove that the insulation was not damaged during the drying process. This recovery method saved the facility over \$500,000 and weeks of reconstruction.

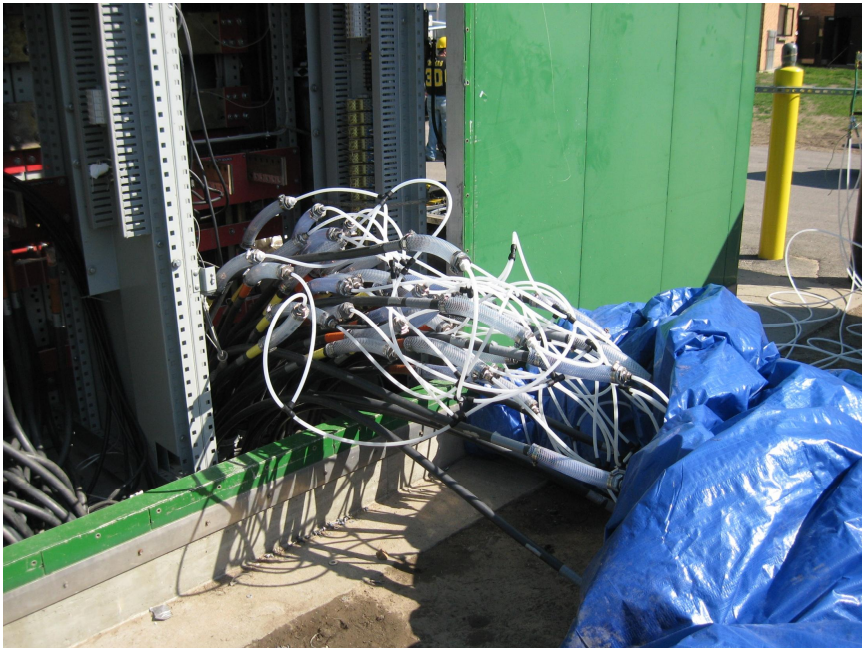
Figure 12: Nitrogen Gas Drying Manifold. *Photo by Ron Demers.*
