REVISED FLOOD MAPS CAUSE WARWICK TO RECONSIDER THE SAFETY OF ITS TREATMENT PLANT

Dennis Setzko^{1*}, Erik Meserve², Janine Burke³, Joel Burke³, and Patrick Doyle³

¹ AECOM, 500 Enterprise Drive, Suite 1A, Rocky Hill, CT 06067

³ Warwick Sewer Authority, 125 Arthur W. Devine Boulevard, Warwick, RI 02886

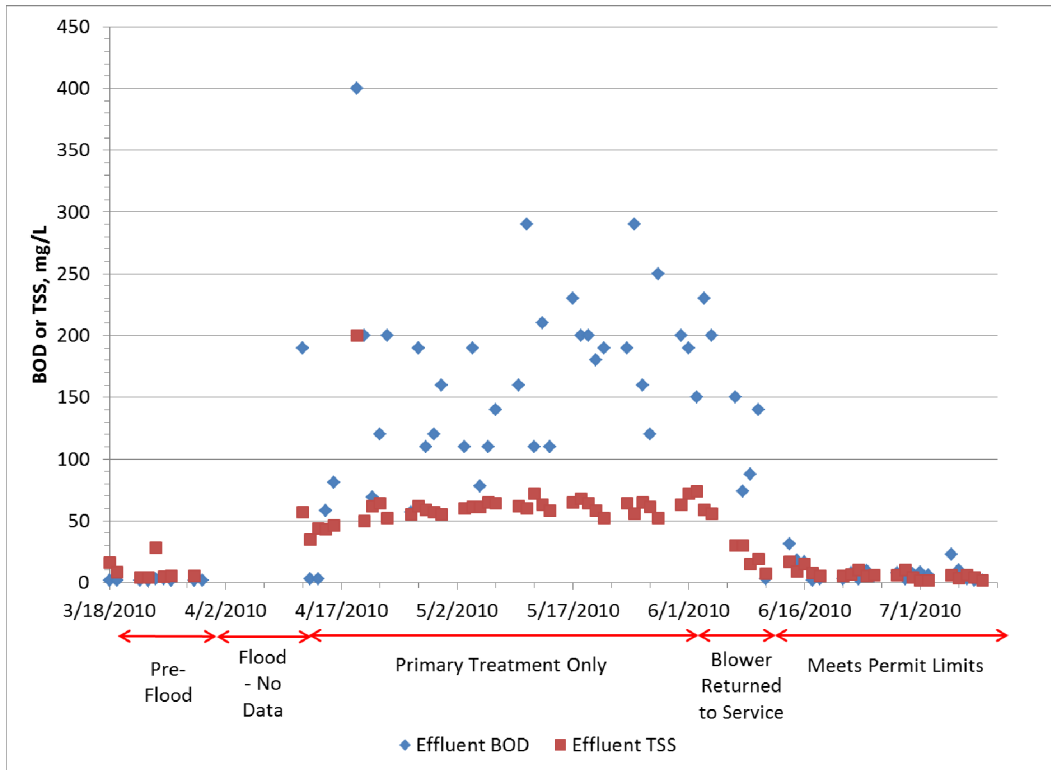
As restoration began, portable generators were connected to newly installed temporary electrical patch panels at each of the different buildings. Buildings were cleaned and disinfected, mechanical equipment was inspected and service needs identified and then performed, and electrical motors were either baked or replaced depending on criticality of operations and availability. When replaced, motors over 1HP in size were replaced with Premium Efficiency motors. Beginning first with primary treatment and drip disinfection and followed by secondary treatment, the plant saw treatment slowly restored over the course of several weeks. [Figure 8](#) and [Figure 9](#) display effluent quality during the months after the flood with major milestones noted.

Figure 8: WSA Effluent Data for BOD and TSS

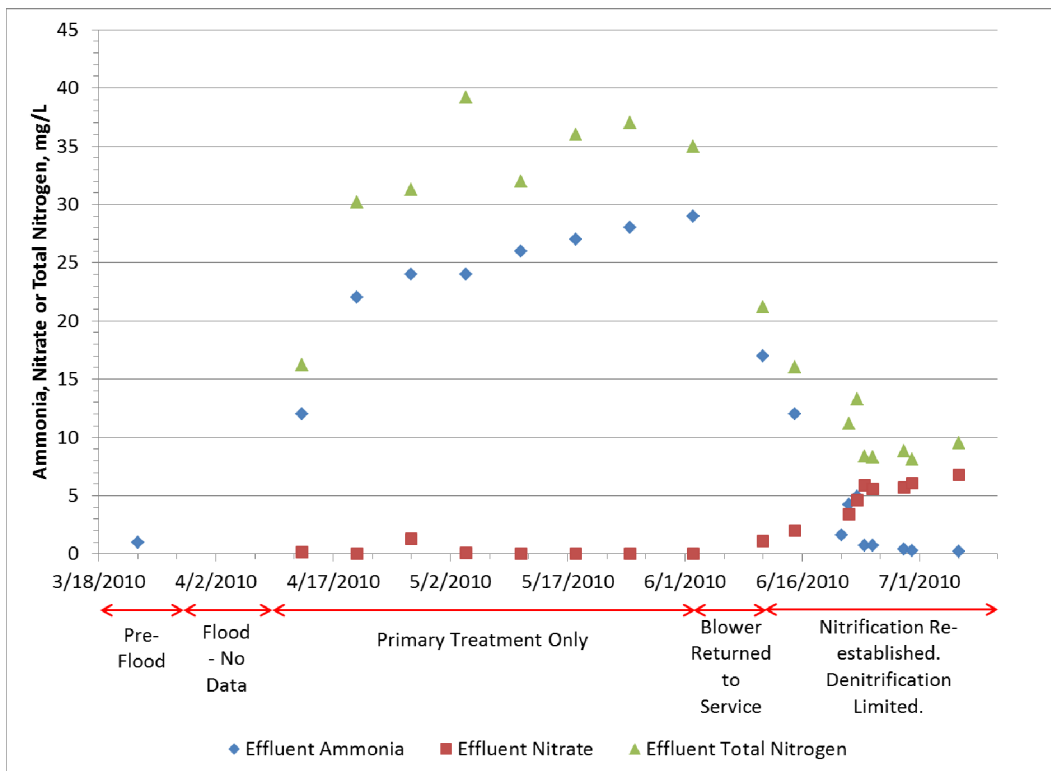
Figure 9: WSA Effluent Data for Ammonia, Nitrate and Total Nitrogen
